NEW HAMPSHIRE HISTORIC PROPERTY DOCUMENTATION
BICKFORD RENTAL HOUSE
NH STATE NO. 689

- Location:** 785 First Avenue, Berlin, Coos County, New Hampshire
- USGS Berlin Quadrangle
UTM Coordinates: Z19 4926353N 326093E
- Present Owner:** State of New Hampshire

- Project Info.:** Project personnel included Lisa Mausolf, Historian, and Charley Freiberg, Photographer. Existing Conditions Surveys, Inc. prepared the plans. This documentation is mitigation for the relocation of NH Route 110 through the Berlin Heights Neighborhood Addition Historic District. This document draws extensively from earlier documentation prepared by Preservation Company including The Avenues/Berlin Heights Addition Historic District Area Form 2004 and the 2008 addendum. The large format photographs were taken in October 2010 and June, September and October 2011 and the report was finalized in August 2015. The building was demolished in Fall 2012.

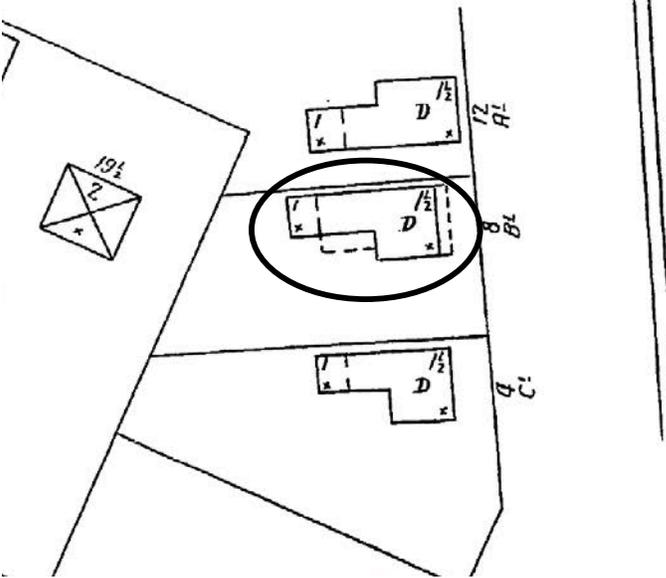
Sanborn Insurance Map, Feb. 1905

785 First Ave. is at center (circled)

The entire east façade is fronted by a single-story, hip-roofed enclosed porch accessed by stone and concrete front stairs. All three of the houses were originally constructed without porches. The 1901 Sanborn map shows the house without a porch but it had been constructed by the time of the February 1905 map, apparently added by the original owner who did not sell the property until 1907. (The other two houses at 779 and 789 First Avenue did not see the addition of porches until after 1950.) The porch was enclosed at a later, unknown date. As seen today, the porch has continuous 1/1 storm windows with an exterior wooden door featuring four horizontal panes of glass over a panel.

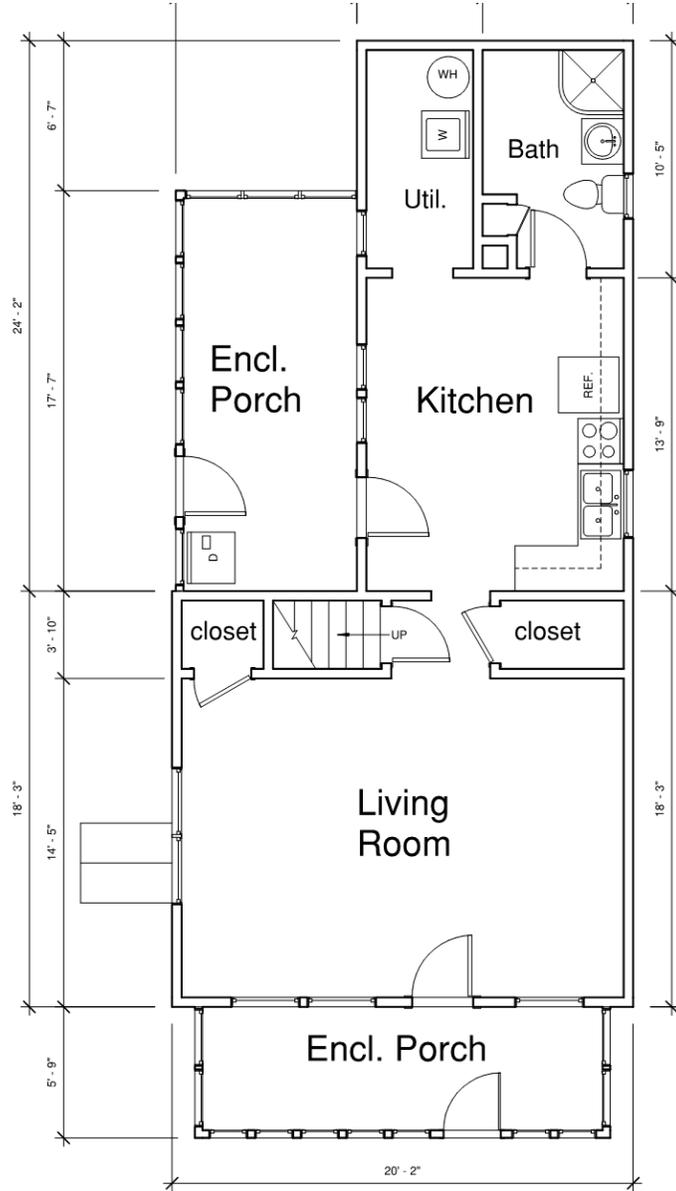
Existing First Floor Plan

FIRST FLOOR 1
09

The building at 785 First Avenue was constructed in 1899 as a single-family dwelling and has served that purpose since its construction. The house like its neighbors at 779 and 789 First Avenue employed a plan found in many small houses of the period. There is a large front room, entered directly through the front door, with the kitchen in the rear ell and several small bedrooms on the second floor accessed by a stair between the main block and rear ell.¹ Today, the main entry into the house is through the enclosed front porch. The interior walls of the porch have been covered with paneling. The off-center front door is a modern unit with 3 x 2 upper lights. To the north is a single window; on the south side of the entrance there is a pair of 1/1 windows.

Inside, the walls of the living room are covered with plywood sheets that have been varnished or polyurethaned. Adjacent to the front door, a wooden post gives rise to an east-west ceiling beam. The reason for the beam is not known although it may indicate a previous room division (a similar beam is visible in 779 First Avenue). The floor is covered in linoleum tiles and the ceiling is covered with fiberboard tiles. A closet is located in the northeast corner of the room and the staircase leading upstairs is located on the west wall, adjacent to the ell.

The rear ell contains the kitchen. The walls are modern drywall with simple baseboards and door and window surrounds. The floor is covered in linoleum and there are painted wooden kitchen cabinets. The rear shed is divided into a bathroom and utility room and are accessed through the kitchen. The walls of the enclosed rear porch, south of the kitchen, are sheathed in vertical, varnished, boards.

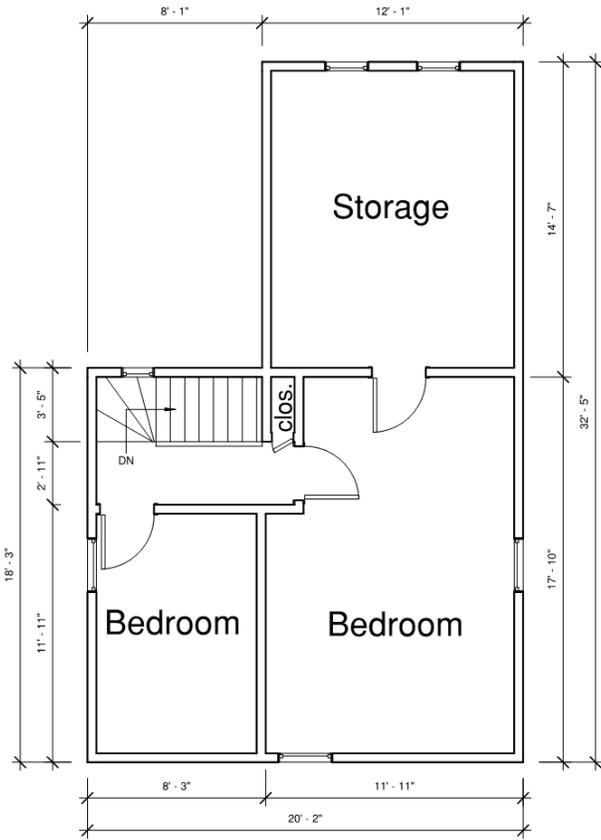
Existing Second Floor Plan

SECOND FLOOR 2
09

The staircase leading upstairs from the living room is narrow and winding with wooden steps with high risers. At the top of the stairs there is a simple stick balustrade with a knobbed newel post. The walls of the staircase are sheathed in modern faux wood paneling. There is a small closet at the top of the stairway wall and a small hallway connects the two front bedrooms. The smaller bedroom to the south has a sloping ceiling with exposed lath and cracked plaster. The walls are papered and the flooring consists of unfinished wood boards. The larger bedroom to the north incorporates the front dormer window. The walls in this room are paneled and the ceiling has surface-mounted acoustical tiles. A door in the west wall of the bedroom leads to a storage area corresponding to the upper level of the rear ell. This unfinished space has a plywood floor and fiberboard attached to the sloping ceiling.

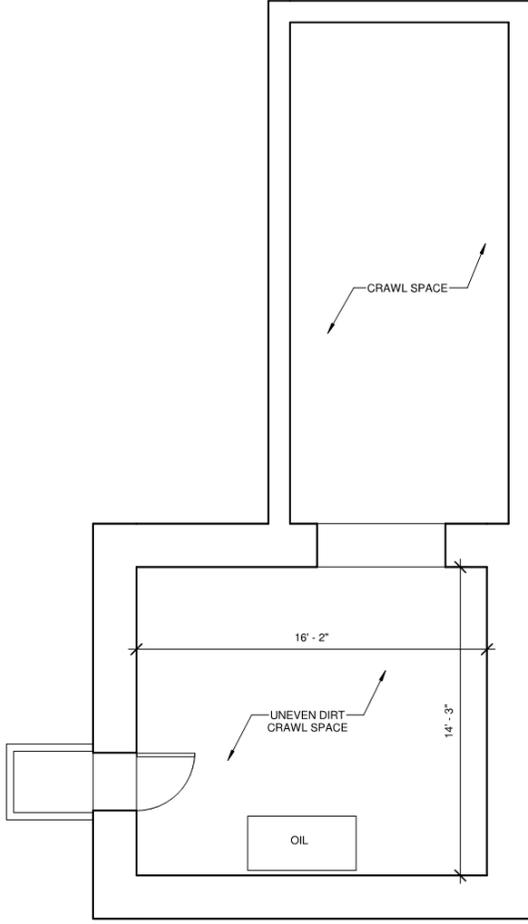
Existing Basement Plan

BASEMENT 0
09

The basement consists of an unfinished crawl space with low head room, stone walls and an uneven dirt floor with rock outcroppings.

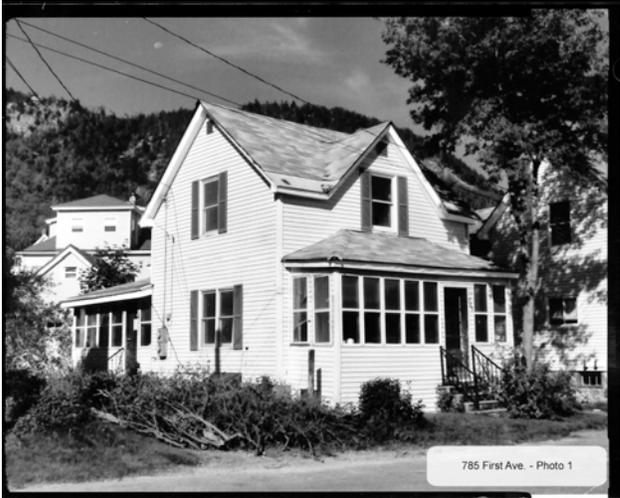
NH State No. 689-1

View looking west showing south and east (façade) elevations. [September 2011]

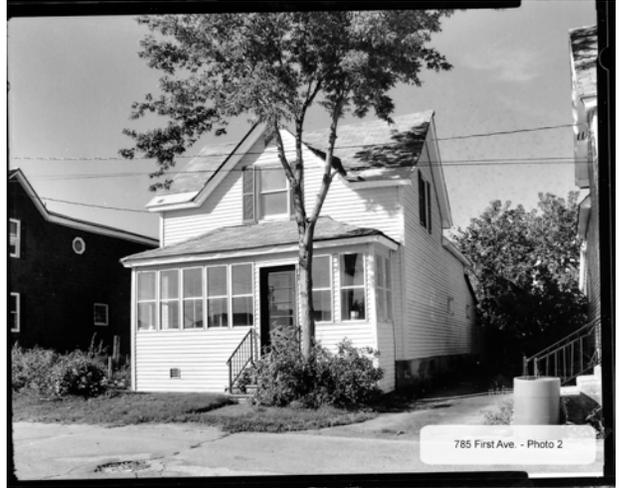
NH State No. 689-2

View looking southwest showing east (façade) and north elevations. [September 2011]

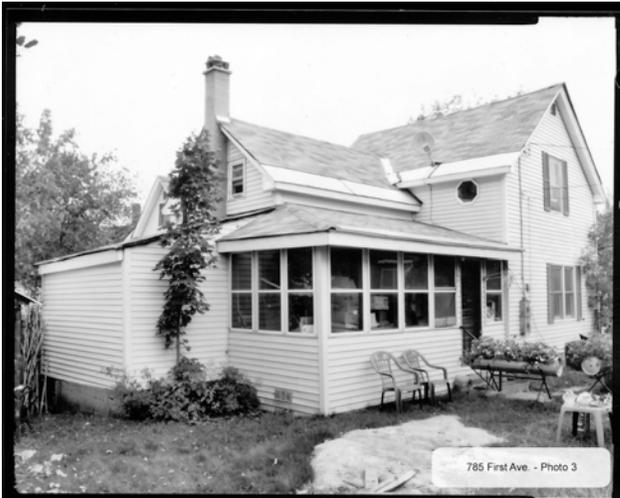
NH State No. 689-3

View looking northeast showing west (rear) and south elevations. [October 2010]

Extending behind the main house block is a 1 ½-story ell, aligned with the northern wall. Like the main house, it is sheathed in vinyl siding. An exterior, concrete block chimney rises along the west wall of the ell, punctuating the single story shed at the west end. A single-story, hip-roofed porch is located on the south side of the ell. Its date of construction is not clear. A porch is shown in this location on the 1905 Sanborn map but is not depicted on subsequent maps (Sanborn Maps, 1909-1950). Like the front porch, it was enclosed by continuous 1/1 windows at an unknown date.

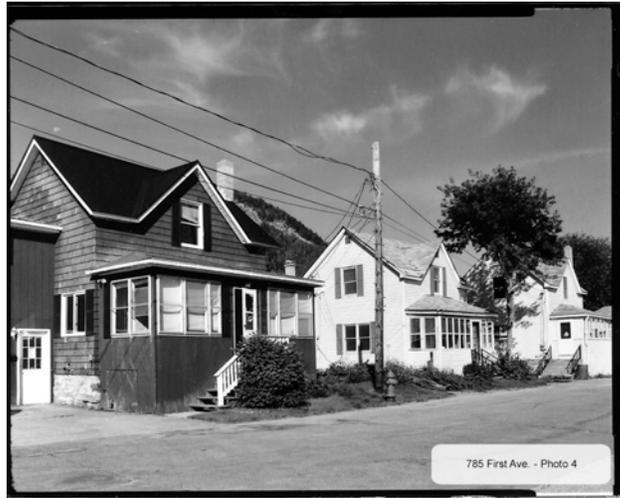
NH State No. 689-4

View looking northwest showing 779, 785 & 789 First Avenue. [September 2011]

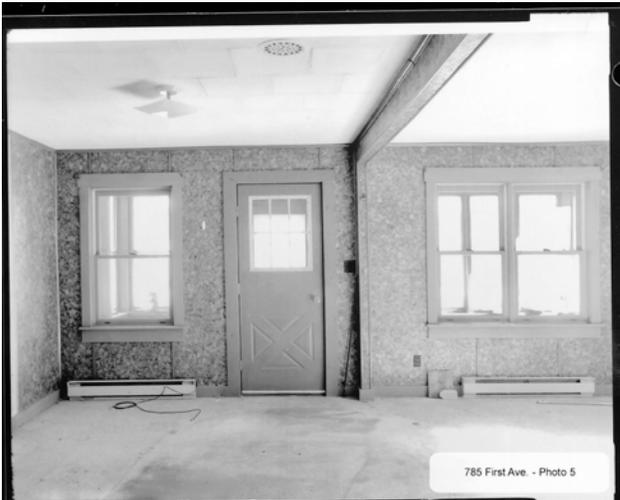
NH State No. 689-5

Interior, first floor living room, looking northeast toward front door. [October 2011]

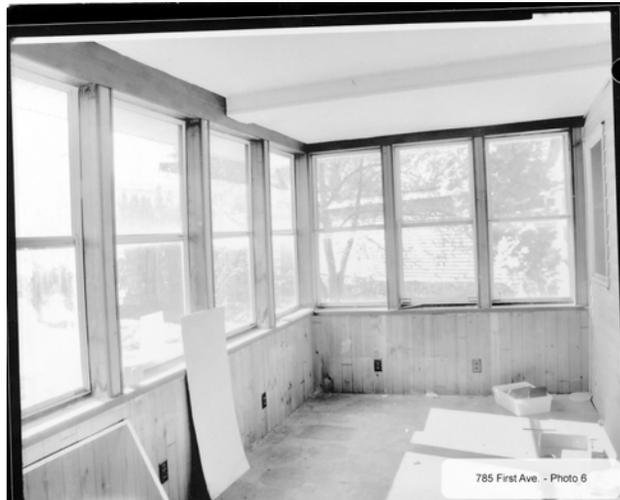
NH State No. 689-6

Interior, inside south porch, looking west. [October 2011]

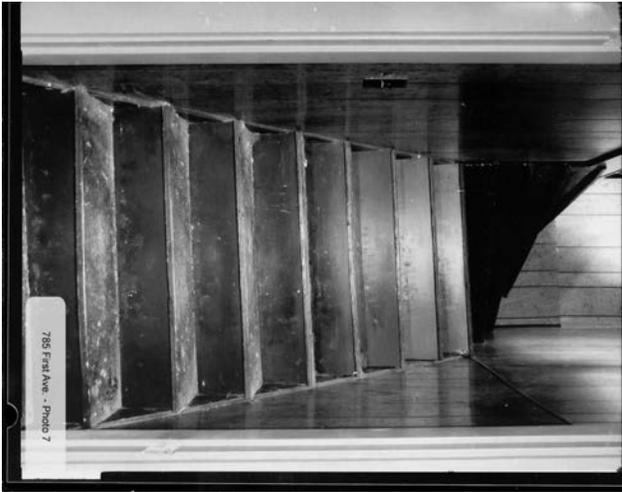
NH State No. 689-7

Interior, first floor, looking south up stairs to second floor. [June 2011]

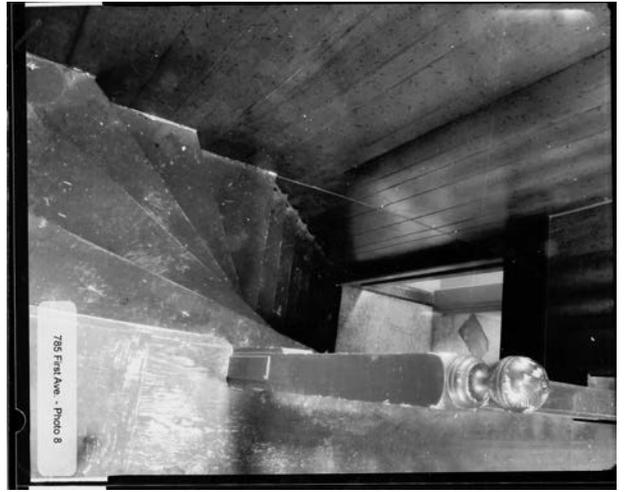
NH State No. 689-8

Interior, second floor, looking north, down stairs to first floor. [June 2011]

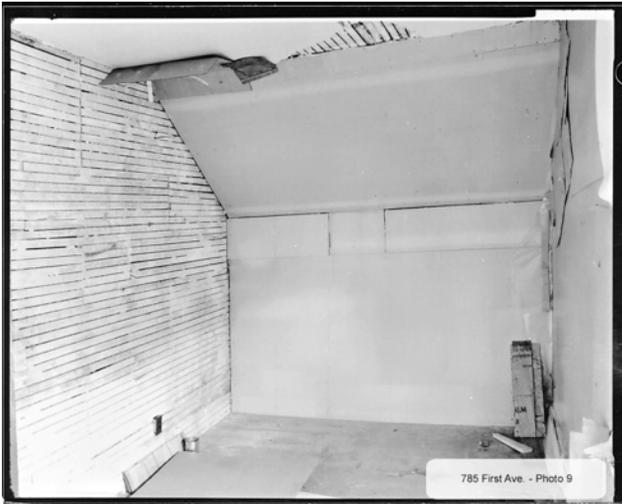
NH State No. 689-9

Interior, second floor, looking northeast toward front wall. [October 2011]
