NEW HAMPSHIRE HISTORIC PROPERTY DOCUMENTATION
GOUDREAU HOUSE
NH STATE NO. 694

Location: 851 Second Avenue, Berlin, Coos County, New Hampshire

Goudreau House
851 Second Avenue
NH State No. 694 (Page 4)

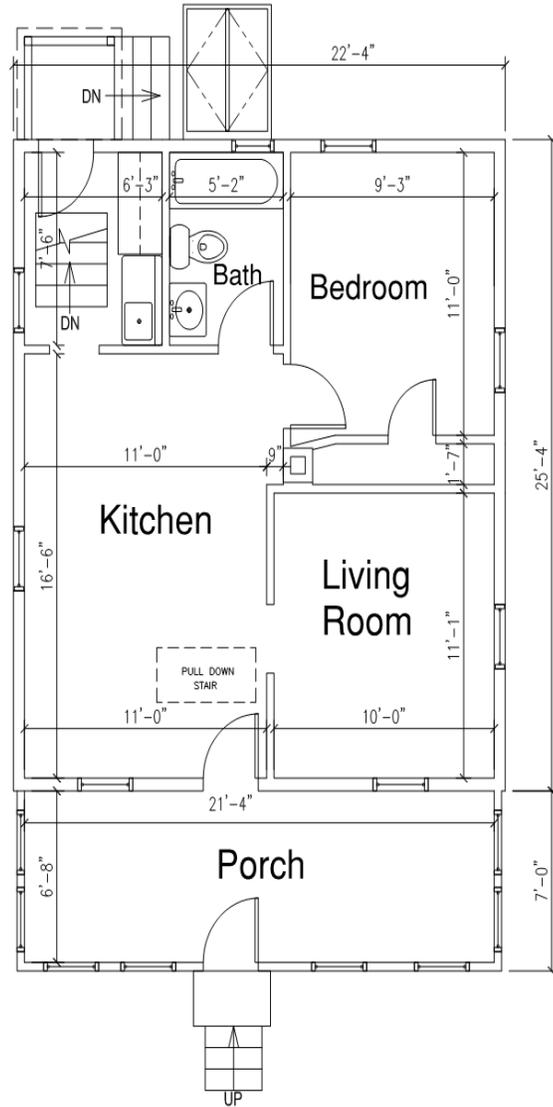
2 EXISTING FIRST FLOOR PLAN
EX-1

Despite its small scale, this house is a good example of the use of the adjacent-room plan. As is common in French Canadian dwellings, the main entrance opens directly into the kitchen, the most important room in the house with the other rooms arrayed around the kitchen.¹

The interior of this modest house has experienced few alterations other than new finishes and the original plan is intact. The front door opens into the kitchen area with a living room to the north. The kitchen has a vinyl floor, fiberboard tiles on the ceiling and a combination of wallpaper and paneling on the walls. A hatch in the ceiling accesses the attic above. To the west of the kitchen is a narrow pantry leading to the glass-and-panel back door. The pantry retains original upper cabinets over a lower base with counter as well as a sink with washboard. A hatch in the floor provides interior access to the basement.

To the north of the kitchen, the living room has fiberboard tiles on the ceiling, paneling and carpeting. Behind the living room, there is a single bedroom with closet. The small bathroom centered on the back (west) wall retains mid 20th century details including a two-panel door, aqua wall tile and fluorescent lights on either side of the rounded rectangular medicine cabinet with metal trim. Both the bedroom and bathroom retain original two-panel doors.

Existing First Floor Plan

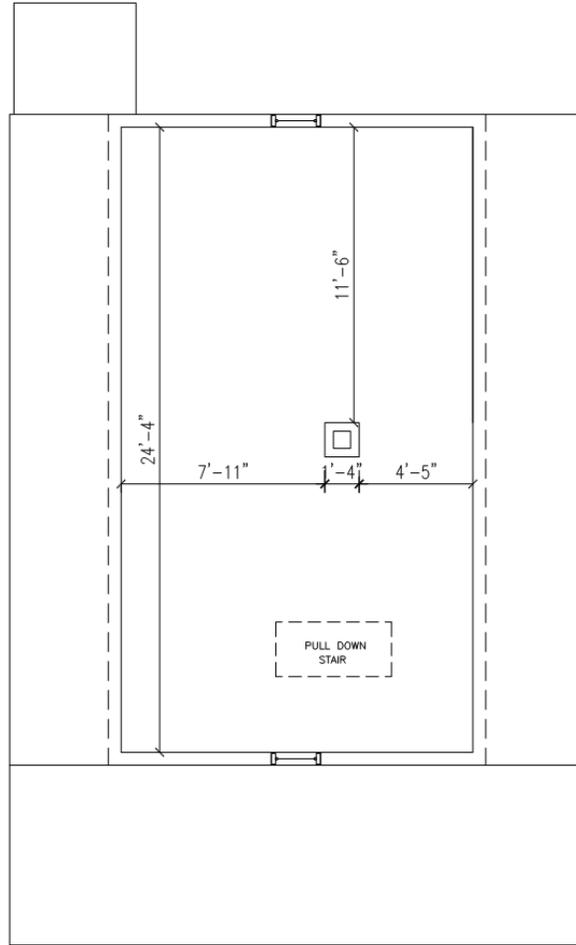
3 EXISTING ATTIC PLAN
EX-1

Existing Attic Plan

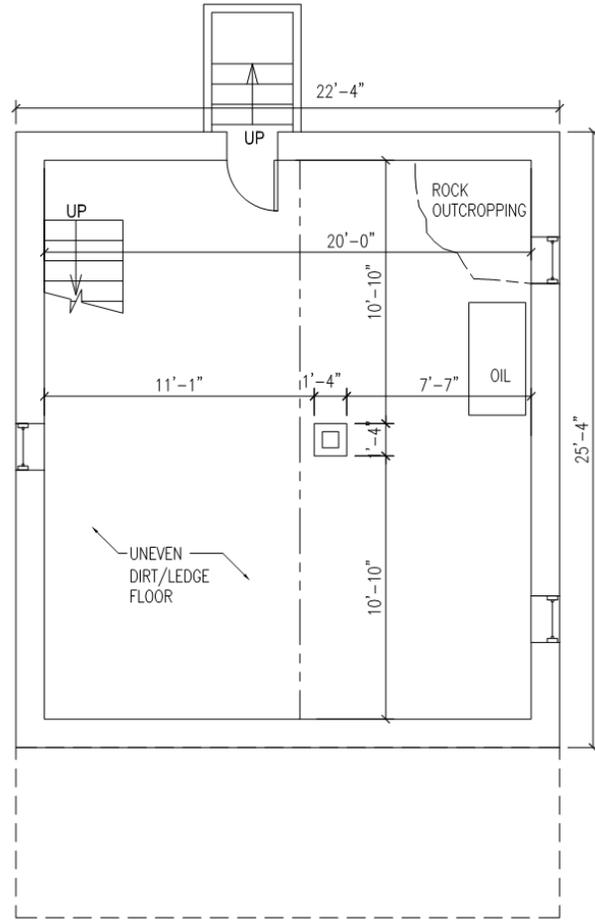
1 EXISTING BASEMENT FLOOR PLAN
EX-1

There is a partial stone foundation with uneven ledge floor under the main house block. The walls of the foundation are built upon ledge outcropping. Due to the uneven nature of the ledge, the average height in this portion of the basement is less than five feet.

Existing Basement Floor Plan

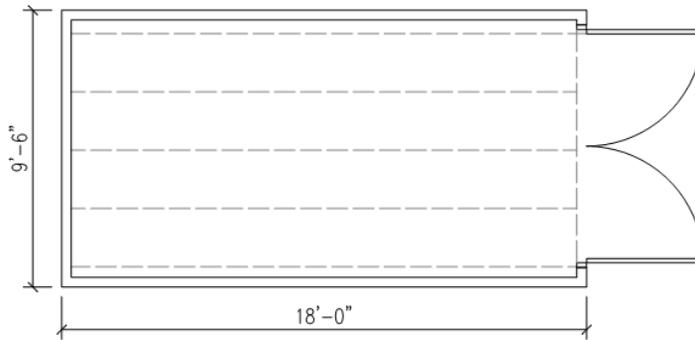
4
EX-1

To the west of the house is a detached shed which is in a dilapidated condition. The walls are sheathed in asphalt “brick” siding and the building is capped by a shed roof with exposed rafter tails on the north end. The building is accessed by double vertical board doors on its north end.

EXISTING SHED PLAN

Existing Shed Plan

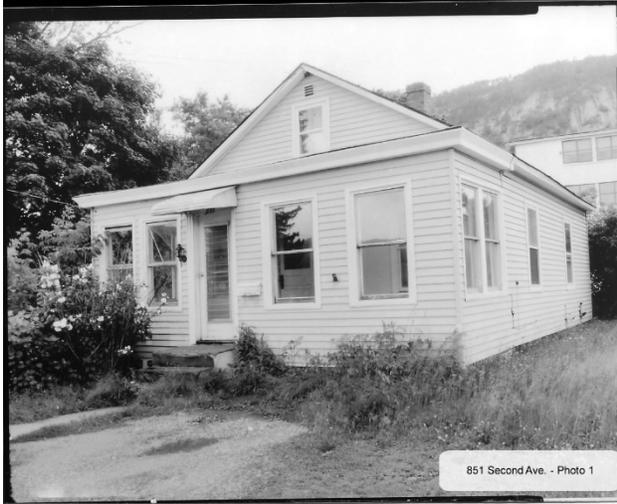
851 Second Ave. - Photo 1

The single-story dwelling is oriented with its low pitch gable front facing east. The house measures approximately 22' x 32' and is set on a rubble foundation. It is presently sheathed in aluminum siding. The roof is sheathed in asphalt shingles with a brick stove chimney rising from the north slope, near the ridge. The entire façade is fronted by a single-story enclosed porch with a smaller, shed-roofed porch sheltering the back door at the southwest corner.

- NH State No. 694-1 View looking southwest at east (façade) and north elevations. [October 2010]
- NH State No. 694-2 View looking northwest showing south and east (façade) elevations. [October 2010]

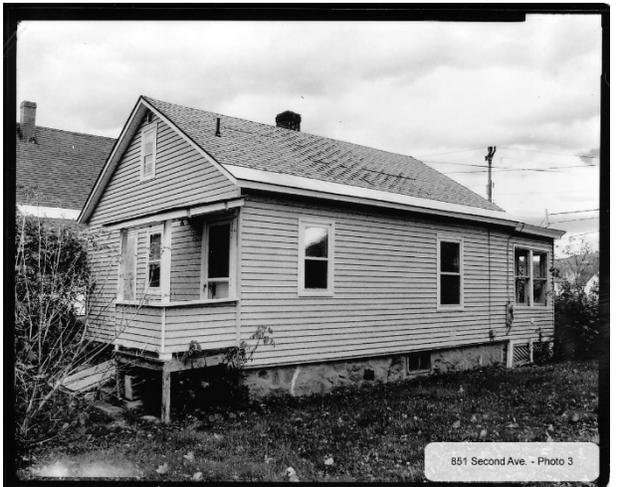
851 Second Ave. - Photo 3

- NH State No. 694-3 View looking northeast showing west (rear) and south elevations. [October 2010]
- NH State No. 694-4 Detail of front porch, looking southwest toward front door. [October 2011]

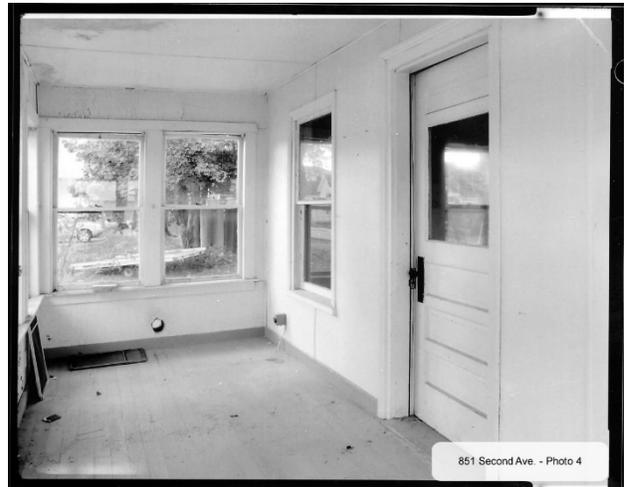
851 Second Ave. - Photo 4

The façade of the front porch is five bays wide with an off-center entrance containing a jalousie door sheltered by an aluminum canopy. Inside the porch is an original glass-and-panel wooden door flanked on either side by a single window. The predominant window on the building is a double-hung 1/1 sash. There are two windows on both the north and south side elevations and a single window in each gable end.

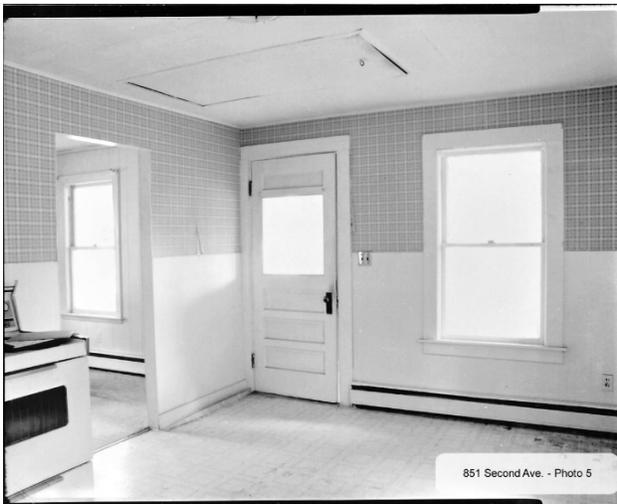
851 Second Ave. - Photo 5

- NH State No. 694-5 Interior view, looking east in kitchen toward front door. [October 2011].
- NH State No. 694-6 Interior view, looking northwest from kitchen toward rear of house. [October 2011].

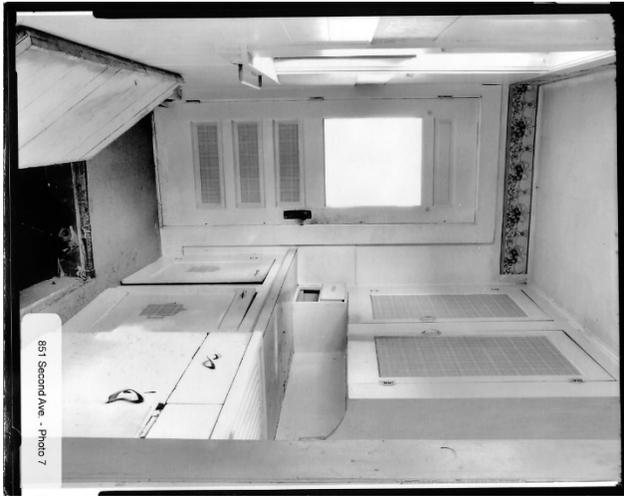
- NH State No. 694-7 Interior view, detail of rear pantry off kitchen, looking northwest. [October 2011]
- NH State No. 694-8 Interior view, basement, looking northwest, showing ledge. [October 2011]

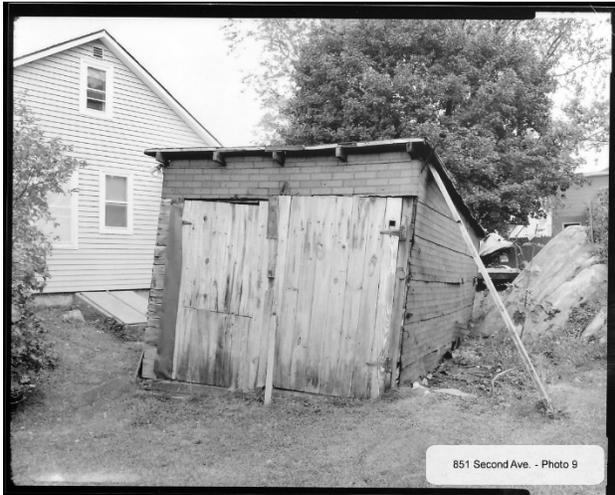
- NH State No. 694-9 Detached shed in back yard looking southeast. [October 2011]
- NH State No. 694-10 Interior view of shed, looking southeast. [October 2011]
