NEW HAMPSHIRE HISTORIC PROPERTY DOCUMENTATION
BRASSARD'S STORE
NH STATE NO. 692

- Location:** 836 Second Avenue, Berlin, Coos County, New Hampshire
- USGS Berlin Quadrangle
UTM Coordinates: Z19 4926346N 326047E
- Present Owner:** State of New Hampshire

- Project Info.:** Project personnel included Lisa Mausolf, Historian, and Charley Freiberg, Photographer. Existing Conditions Surveys, Inc. prepared the plans. This documentation is mitigation for the relocation of NH Route 110 through the Berlin Heights Neighborhood Addition Historic District. This document draws extensively from earlier documentation prepared by Preservation Company including The Avenues/Berlin Heights Addition Historic District Area Form 2004 and the 2008 addendum. The large format photographs were taken in October 2010 and July 2011 and the report was finalized in August 2015. The building was demolished in Fall 2012.

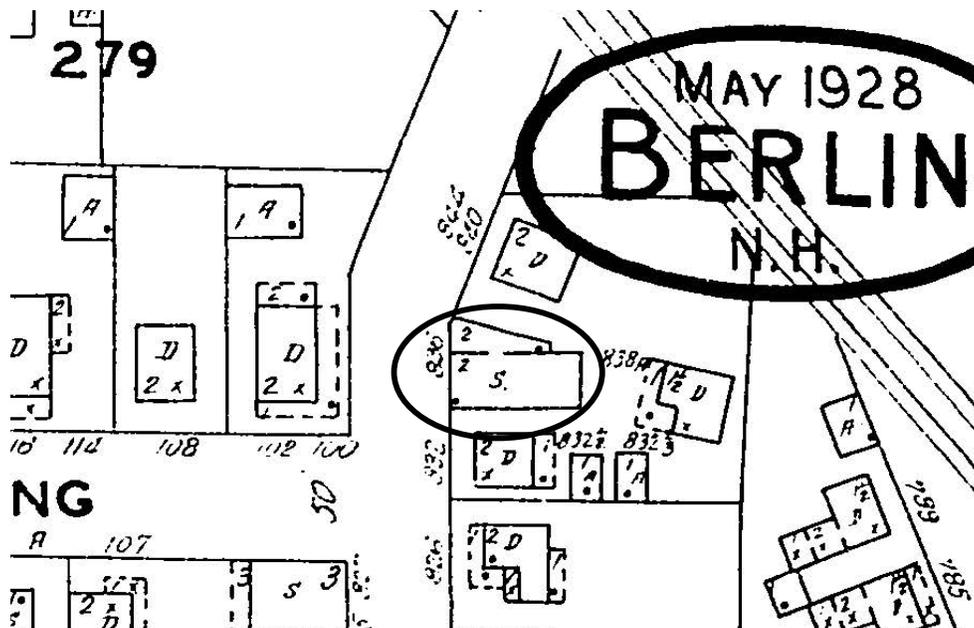
Sanborn map, 1928 (836 Second Avenue is circled)

Building is not depicted on the Dec. 1920 map and the 1950 map looks the same

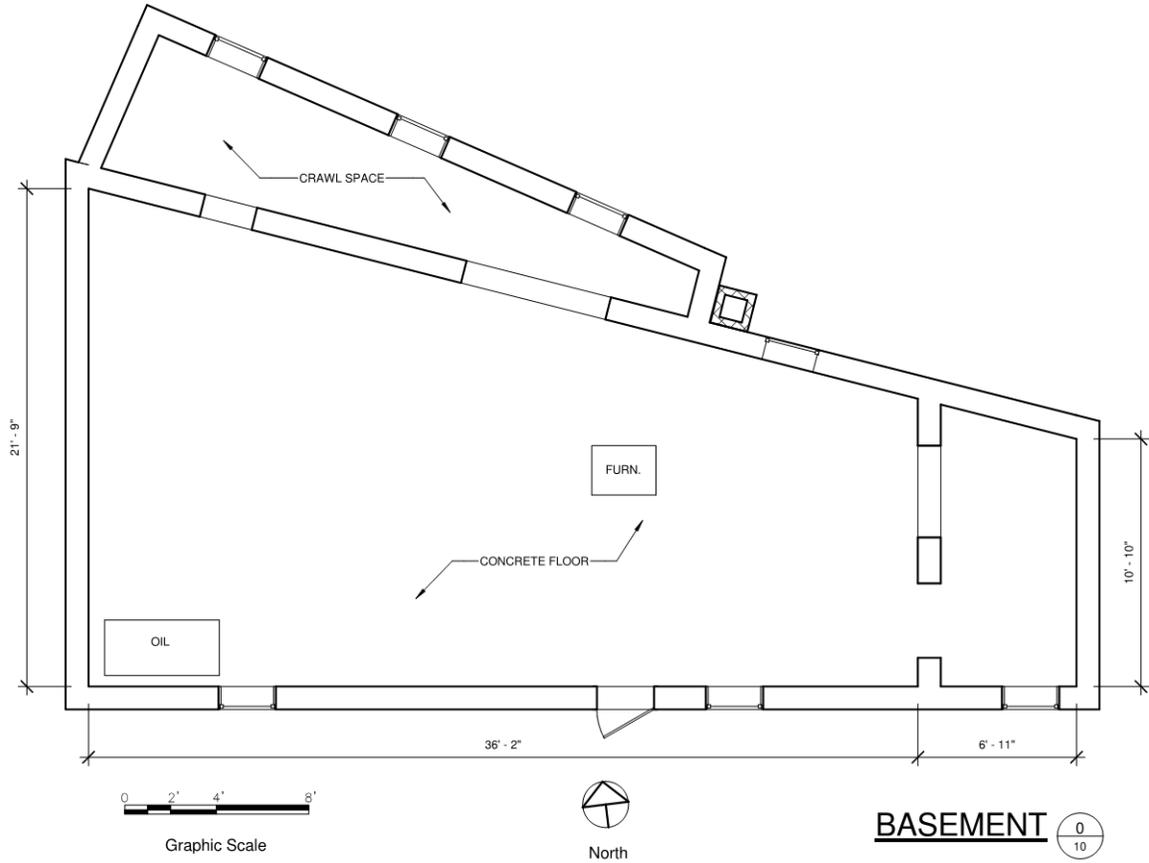
Existing Floor Plan - Basement

As seen today, the interior of the building has been nearly totally gutted to the framing and siding. There is a full basement under the main portion of the building, with a concrete floor. The northern section containing the staircase has only a crawl space with dirt floor. The first floor consists of a large open space with three new wooden posts running in an east-west, off-center line. The north wall of the main volume of the building retains some clapboarding but sections of the wall have been removed. There are also remnants of beadboard on some wall and ceiling surfaces.

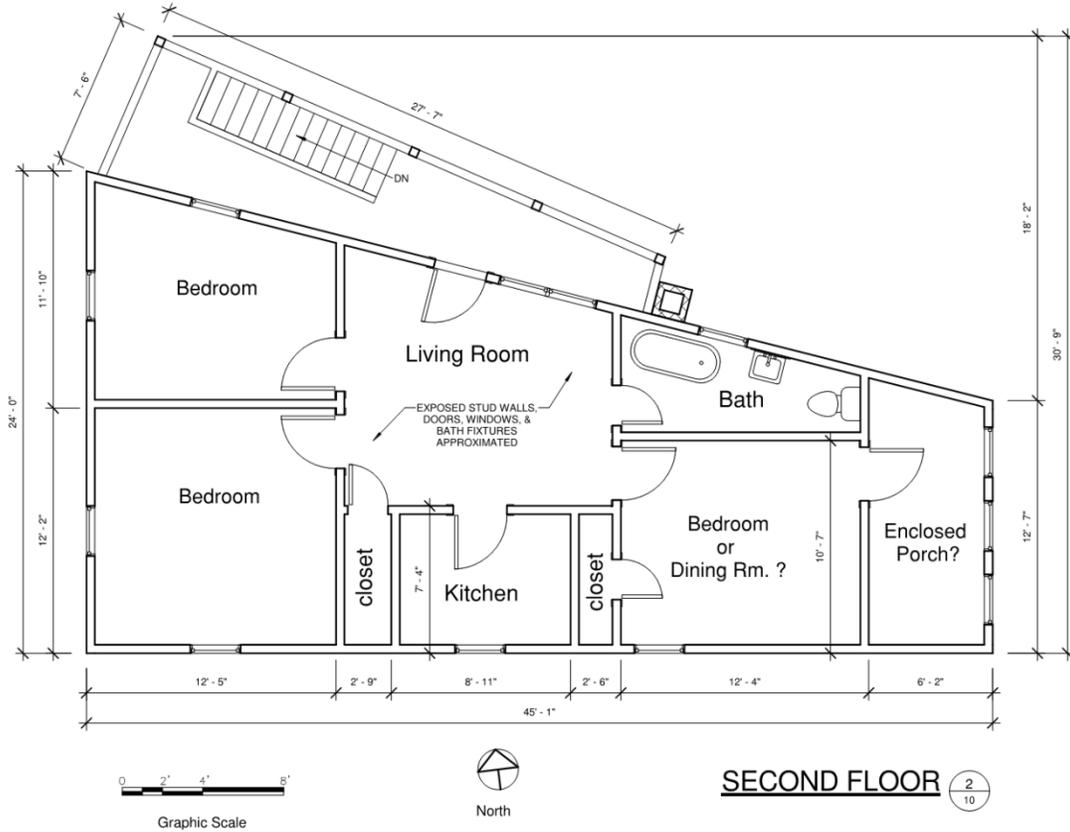
Existing Floor Plan – Second Floor

The second floor of the building, which was historically living space for the family, has been reduced to exposed stud walls. The entry to the apartment is near the center of the north wall and opens onto a small room which would have been a living room. There are two rooms in the front which were probably bedrooms. It appears that the kitchen was located near the center of the south wall with another bedroom or perhaps dining room to the east. The bathroom was located east of the living room. At the east end of the building is a small room with three windows, which may have functioned as a sort of enclosed, sleeping porch.

Note: As seen today (2011) all walls have been removed, exposing studs. This plan shows the former location of doors and bath fixtures as well as room labels based on physical evidence.

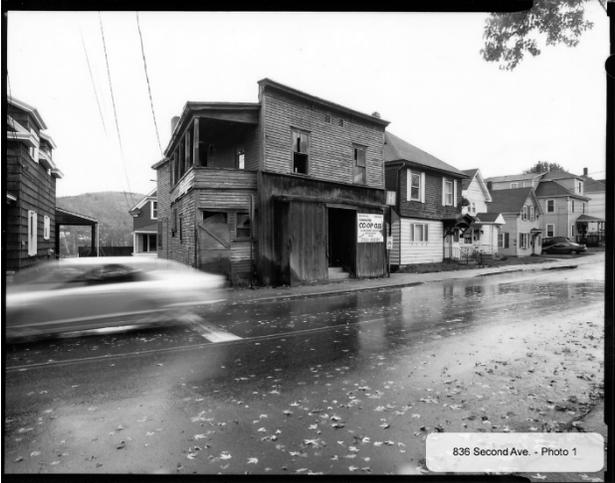
836 Second Ave. - Photo 1

The main, recessed entrance is centered on the west façade, fronted by two concrete steps. The large upper glass in the wooden door is covered with plywood and the flanking angled storefront windows have been replaced by vertical boards. A secondary entrance accessing the stairs leading to the upstairs unit is located on the west wall of the north section. This entrance is also boarded. The first floor level of this entrance contains the staircase and is enclosed with clapboard walls. The open porch above is four bays wide with square posts with caps and bases set on a clapboarded wall, the lower edge of which is punctuated by scuppers.

NH State No. 692-1 View looking southeast from across the street at west (façade) elevation of 836 Second Avenue (with 832 Second Avenue visible at right). [October 2010]

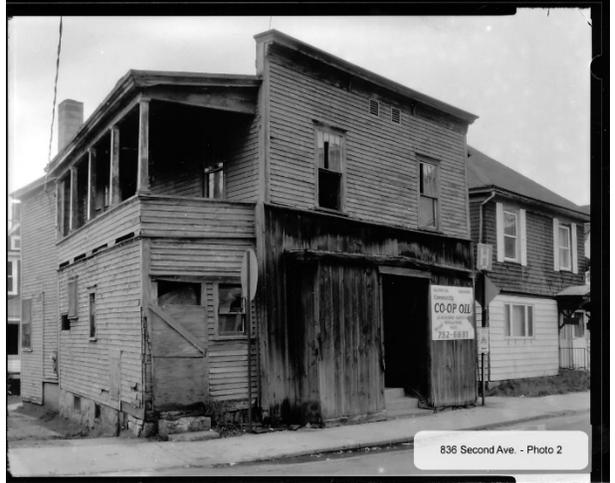
836 Second Ave. - Photo 2

NH State No. 692-2 View looking southeast showing north and west (façade) elevations. [October 2010]

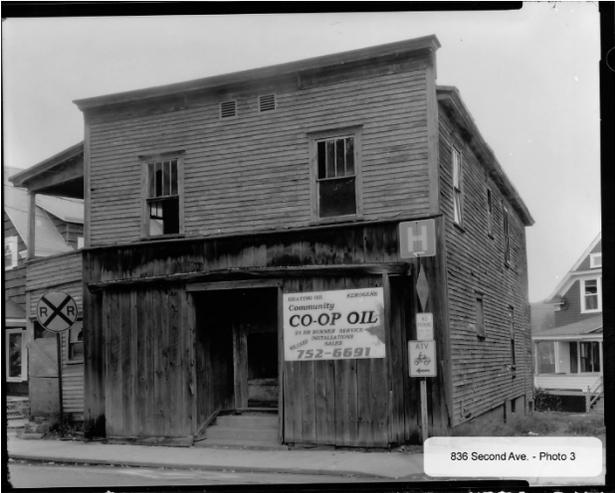
836 Second Ave. - Photo 3

NH State No. 692-3 View looking east showing west (façade) and south elevations. [October 2010]

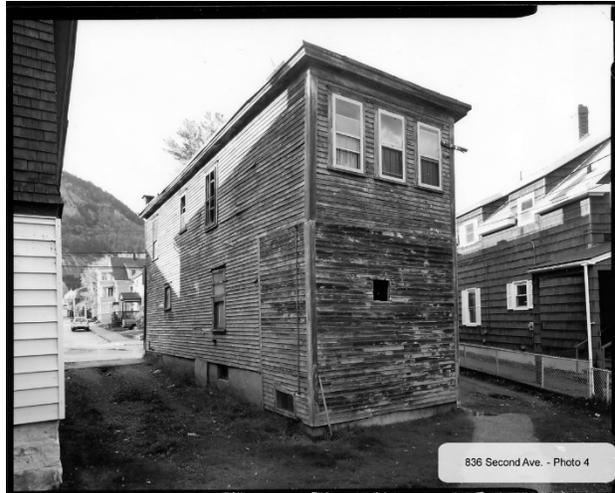
836 Second Ave. - Photo 4

Markings on the clapboards at the rear of the first floor suggest that there may have originally been a recessed porch at the first floor level which was later enclosed.

NH State No. 692-4 View looking northwest showing south and east (rear) elevations. [October 2010]

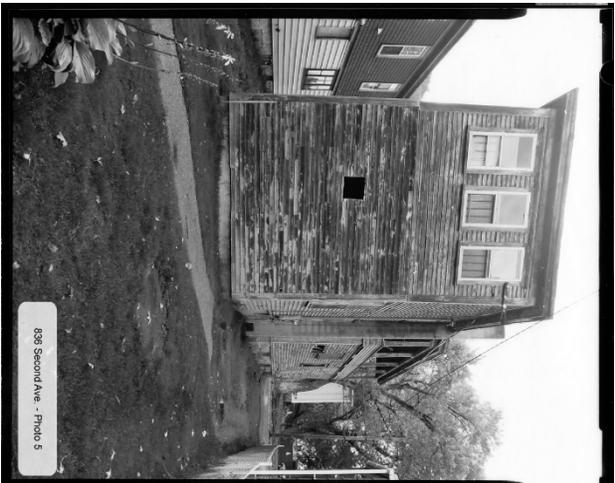
836 Second Ave. - Photo 5

NH State No. 692-5 View looking west at east (rear) and north elevations. [October 2010]

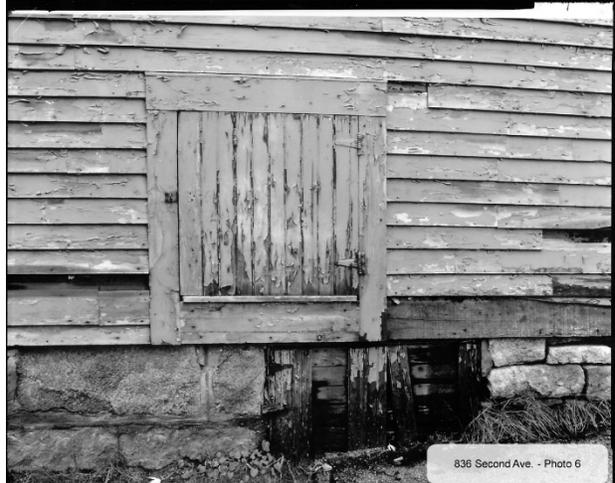
836 Second Ave. - Photo 6

Windows on the first floor of the building include a mix of small elevated fixed units and 2/2 and 1/1 double-hung units, the latter added after the building ceased being used for commercial use. On the upper level the predominant window is a wooden double-hung sash with four vertical lights over a single lower light. The original windows are all capped by simple entablature lintels. There is a small square beadboard door on the north wall near the staircase entrance provided access to the basement, perhaps for coal.

NH State No. 692-6 Detail of north wall showing foundation and door leading to coal bin. [October 2010]

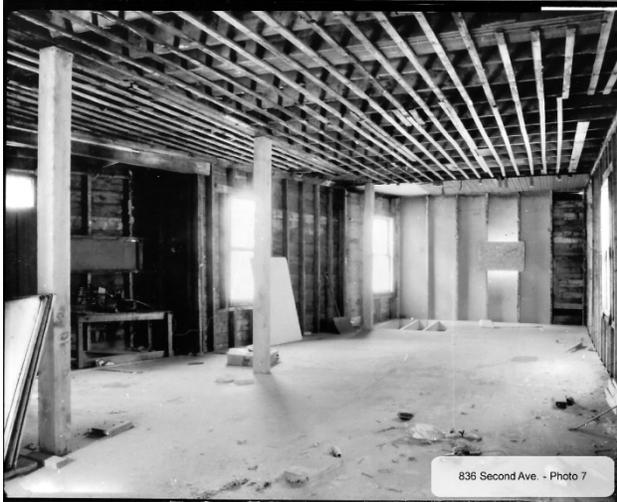
836 Second Ave. - Photo 7

NH State No. 692-7 Interior view of first floor looking east. [July 2011]

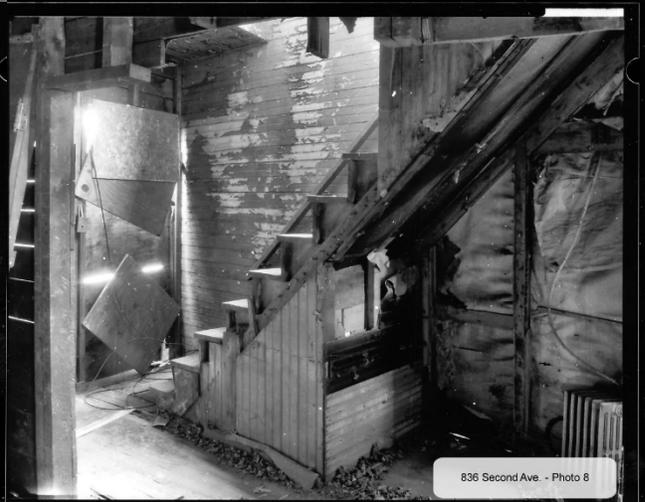
836 Second Ave. - Photo 8

NH State No. 692-8 Interior view of first floor looking northwest showing blocked entrance at left and stairs to second story porch [July 2011]

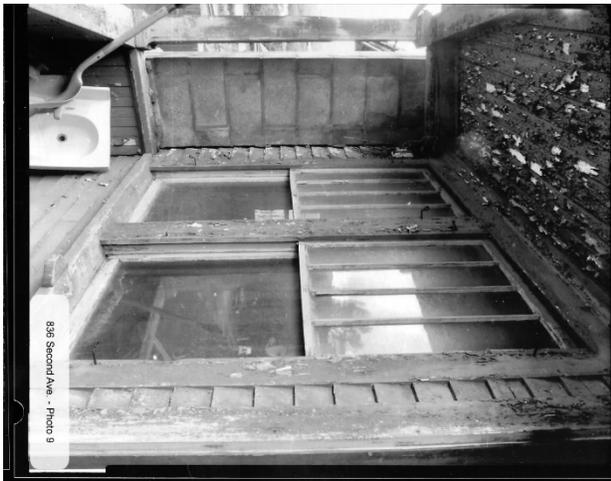
836 Second Ave. - Photo 9

NH State No. 692-9 Detail looking southeast at original wooden windows sheltered by second story porch. [July 2011]

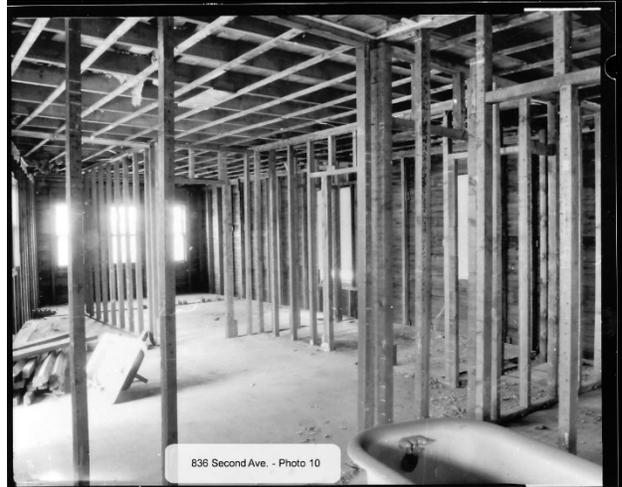
836 Second Ave. - Photo 10

NH State No. 692-10 Interior view of second story looking east. [July 2011]
